Riviera Gardens HOA
Palm Springs, CA

Report #: 46808-0
Beginning: January 1, 2024
Expires: December 31, 2024

RESERVE STUDY
Update "With-Site-Visit"

November 16, 2023

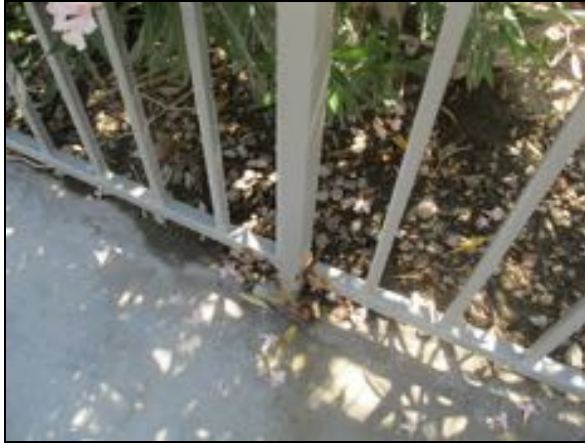
Comments: In our experience, metal fencing will typically eventually break down due to a combination of sun and weather exposure, which is sometimes exacerbated by other factors such as irrigation overspray, abuse and lack of preventive maintenance. For some types of fencing, complete replacement is advisable over recoating or refinishing due to relatively short lifespan of coatings and consideration of total life-cycle cost.

Useful Life:
35 yearsRemaining Life:
14 years
